Manhole Inspection Summary

Manhole # S31II_042MH

Insp Date: **10/16/07 8:37 AM**

Location Address: **121 MOSHER ST**

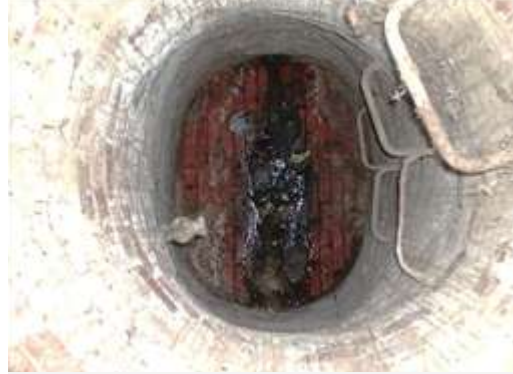
Top View

Corroded steps. Channel debris.

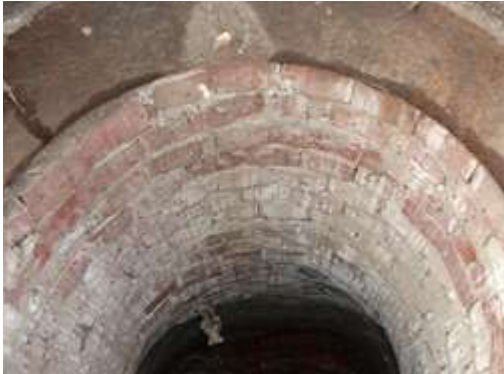
Defect

Frame leaks. Adjustment and Corbel deterioration and infiltration. Barrel infiltration - other sides.

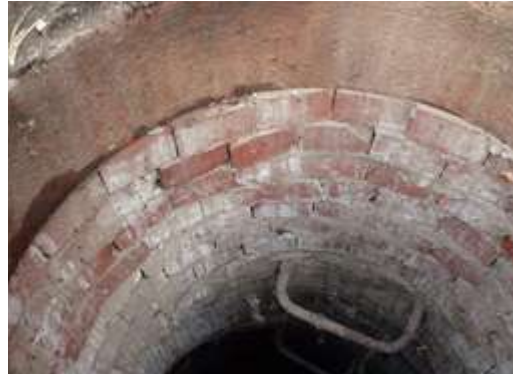
Defect

Frame leaks. Adjustment and Corbel deterioration and infiltration. Barrel infiltration.

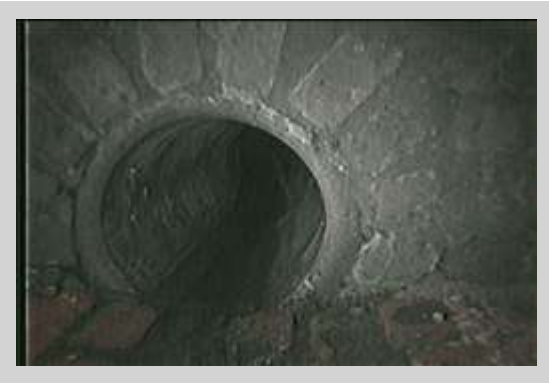
8 in. Circular Gravity Sewer Pipe Out @ 12 O'Clock

Infiltration: **Evidence** Pipe Seal Cond: **Unknown**
